Re: **Mr. Robert Eichenour Private Homeowner Construction Site; Construction Stormwater; SIC 1522; NPDES Compliance Evaluation Inspection; NPDES #NMU001987; February 27, 2019**

## NPDES Compliance Inspection Report

**Inspection Report: Clean Water Act Section 401 & 404**  
**La Canada Del Carro**  
**Surface Water Quality Bureau (SWQB)**  
**Watershed Protection Section**

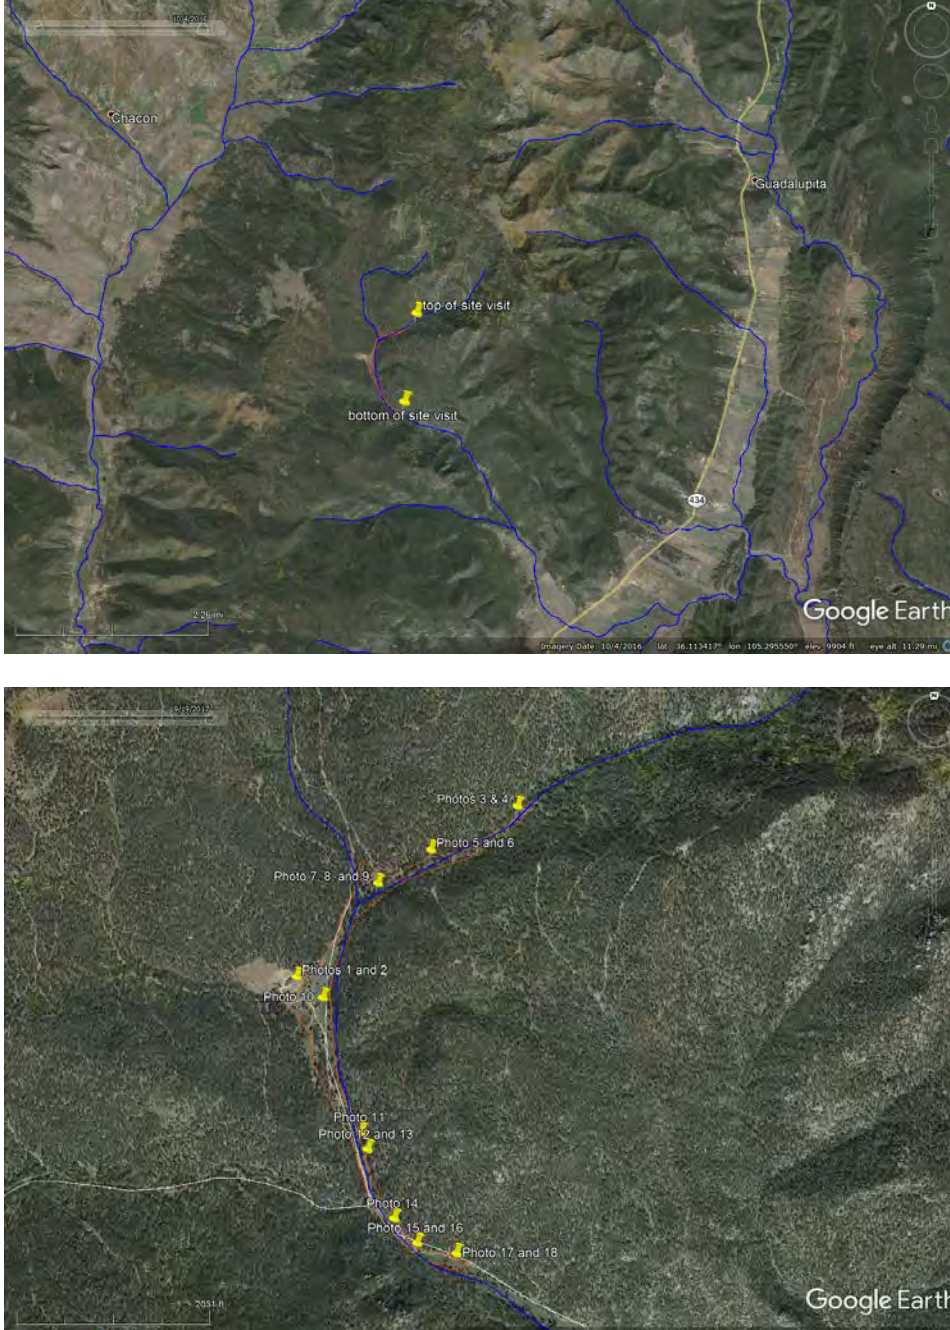
Description	Image: Google Earth
<p>Google Earth image of the general location the site visit, 5-miles southwest of Guadalupeita.</p> <p>Yellow markers indicated the top and bottom of the site visit and the photo points.</p> <p>The red outline is the approximate area where clearing and grading activities were observed – approximately 30 acres.</p> <p>The blue stream lines are from the National Hydrography Dataset.</p>
